## **Demonstration and Validation of a Lightweight Composite Bridge Deck Technology as an Alternative to Reinforced Concrete**

Final Report on Project F09-AR16

August 2016

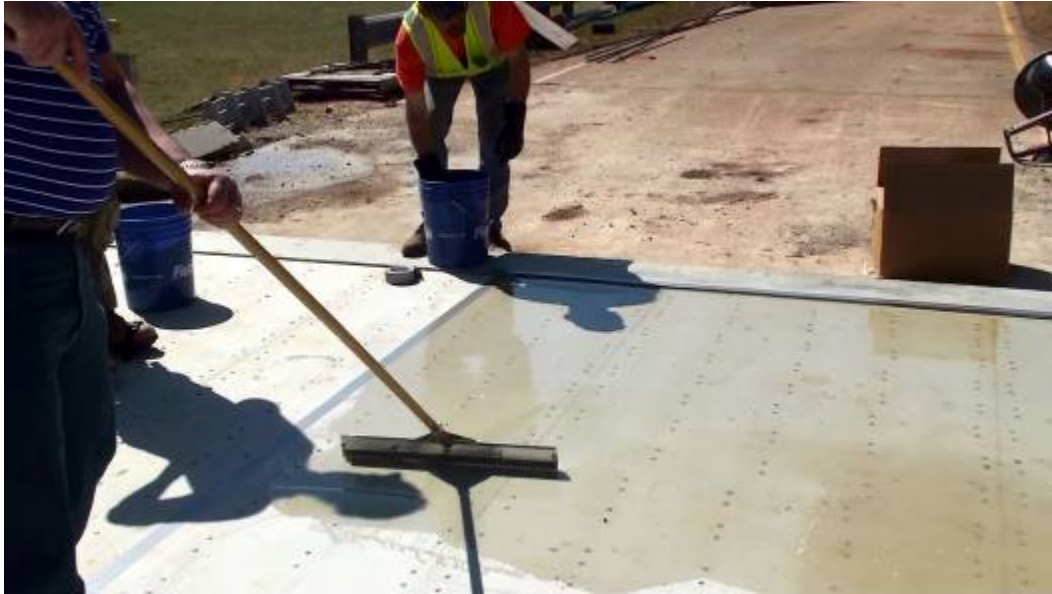
Figure 42. Application of polymer material.

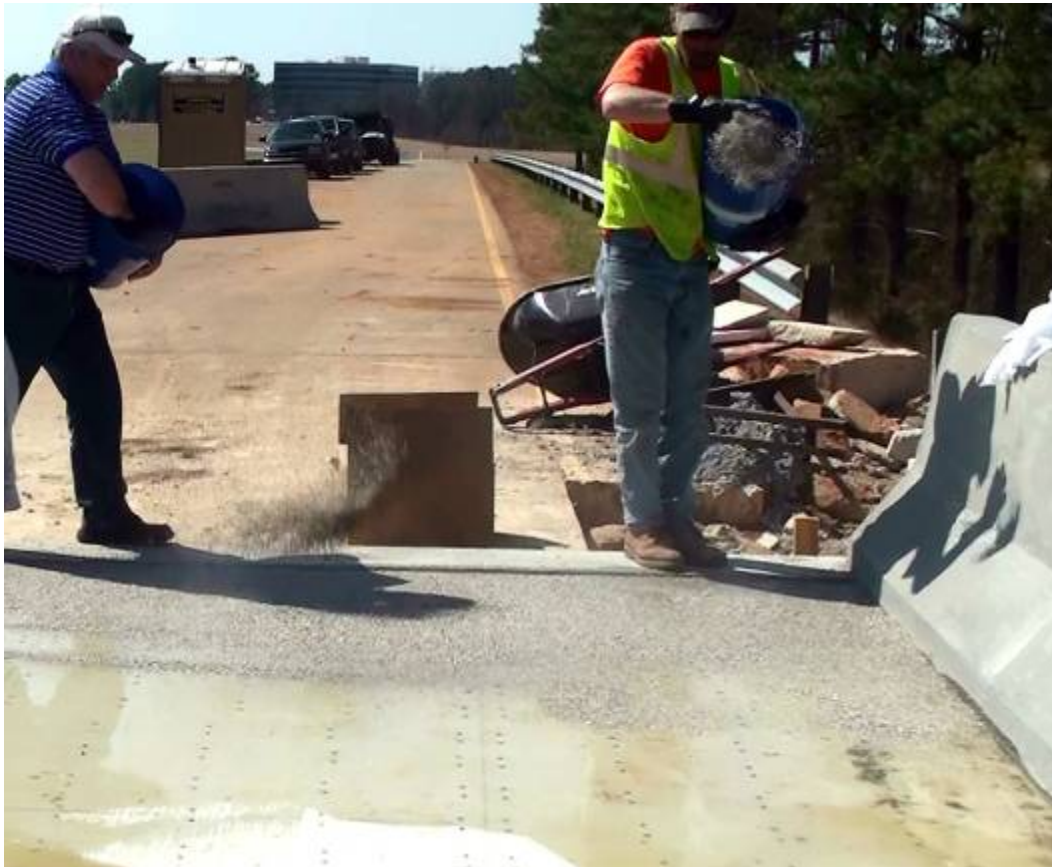
Figure 43. Broadcasting aggregate to complete polymer concrete.

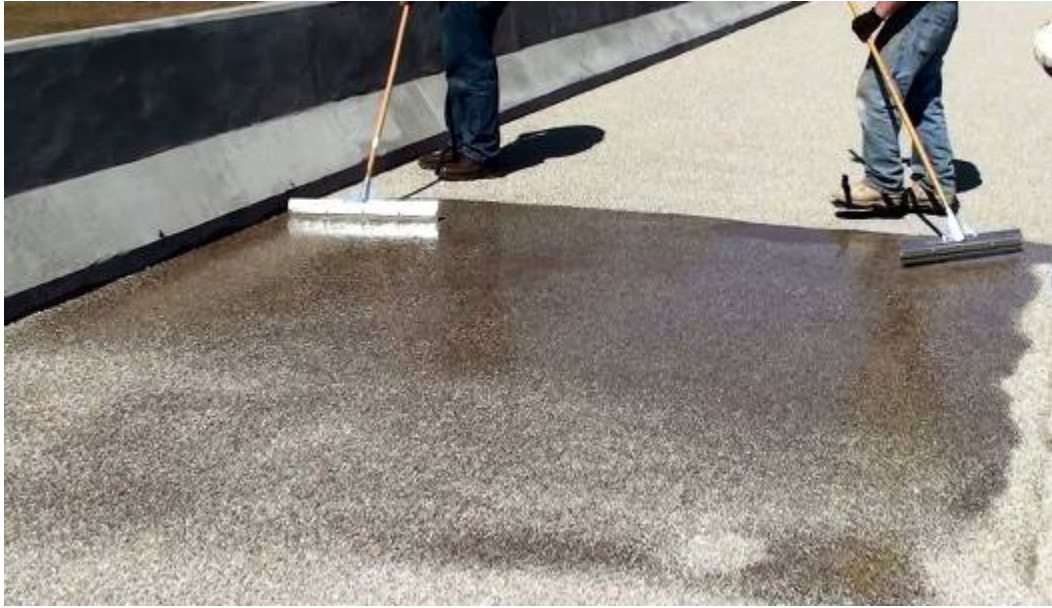
Figure 44. Application of second coat of polymer.

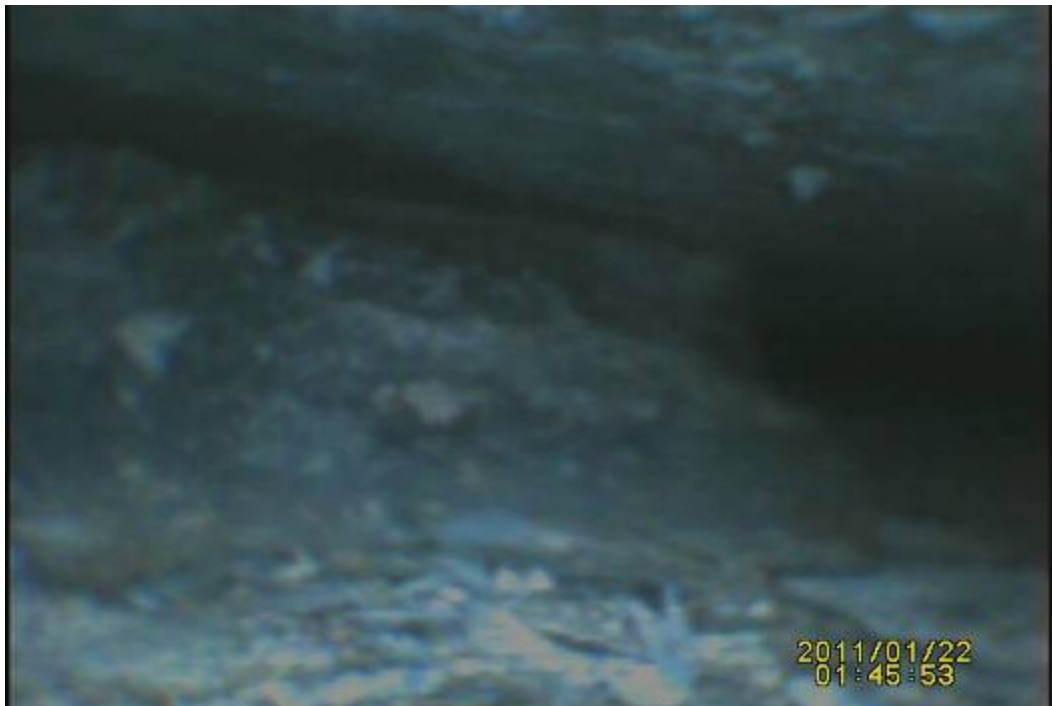
MEC also conducted a borescope inspection of the interior of several voids and several deck channels. During these inspections, no significant amount of water or external debris was observed in either the deck sections or in the voids. Figure 65 and Figure 66 show the interior of two voids. The bottom of the deck can be seen faintly at the top of each figure. Figure 67 and Figure 68 show the interior of composite deck sections. The deck surface and foam dam material for a grout pocket are visible.

Figure 66. Borescope view of void interior.

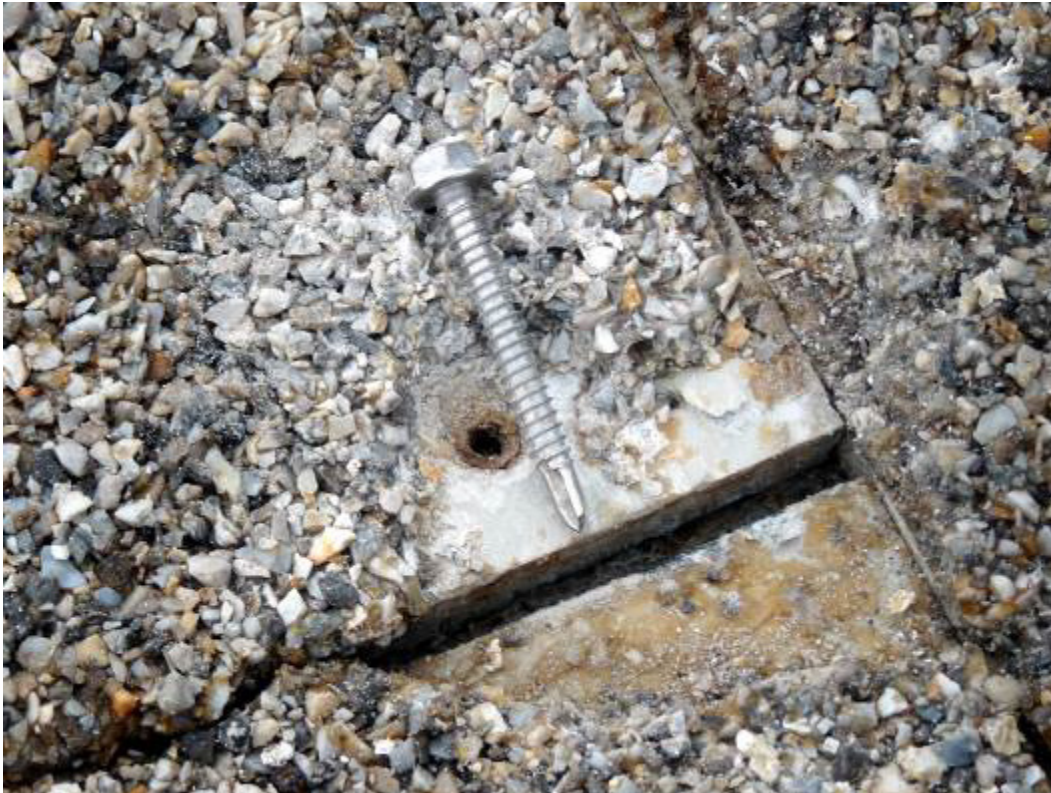
Figure 70. Fastener removed from GFRP composite sheet.

Repairs to the wear surface and voids began 16 May 2011. First, dirt and other foreign materials were removed from the cracks adjacent to the raised flat composite sheets supporting the wear surface. The wear surface material was then removed to expose the closest fasteners (Figure 69). The exposed fasteners were removed to check whether the threads had damaged the composite material (Figure 70). Although not visible in Figure 70, in all cases the screws had in fact been overtightened, shearing the composite material and contributing to the panel raising. Replacement fasteners were installed adjacent to the original ones, and fasteners were added to help prevent any future panel lifting (Figure 71, Figure 72, and Figure 73). In all instances, replacing the fasteners returned the composite sheets to sit flush with the adjacent ones. Figure 73 shows two locations where extra screws were added before wear surface repair. The same area after the first application of polymer concrete is shown in Figure 74. The completed repair, before full cure, is shown in Figure 75.

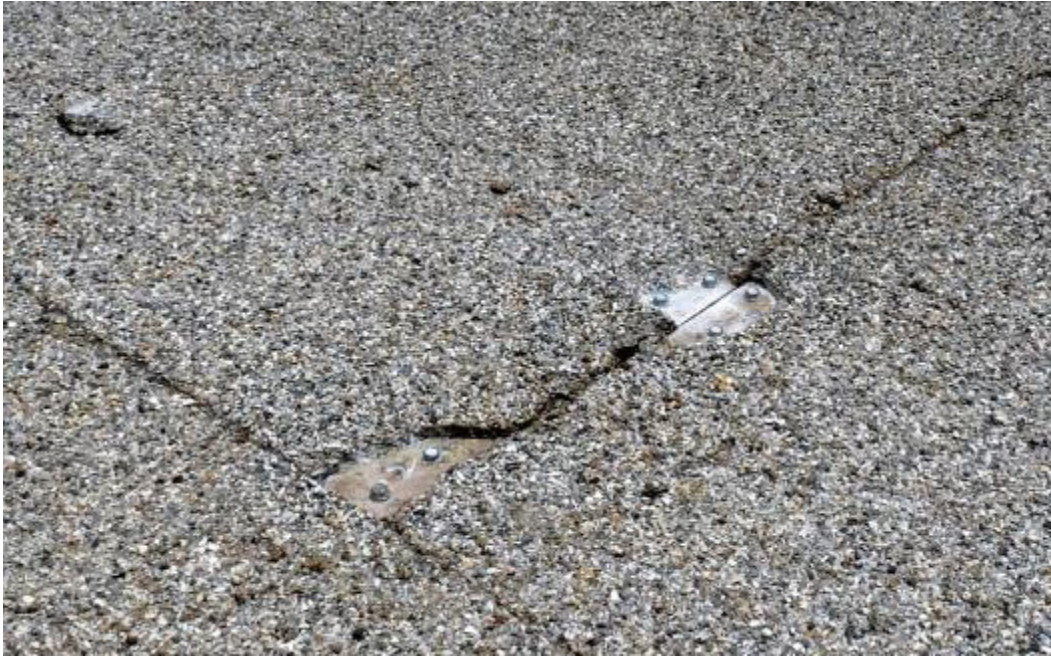
Figure 71. GFRP composite sheets with additional fasteners installed.

Figure 72. GFRP composite sheets with additional fasteners installed.

Figure 73. GFRP composite sheets with additional fasteners installed.

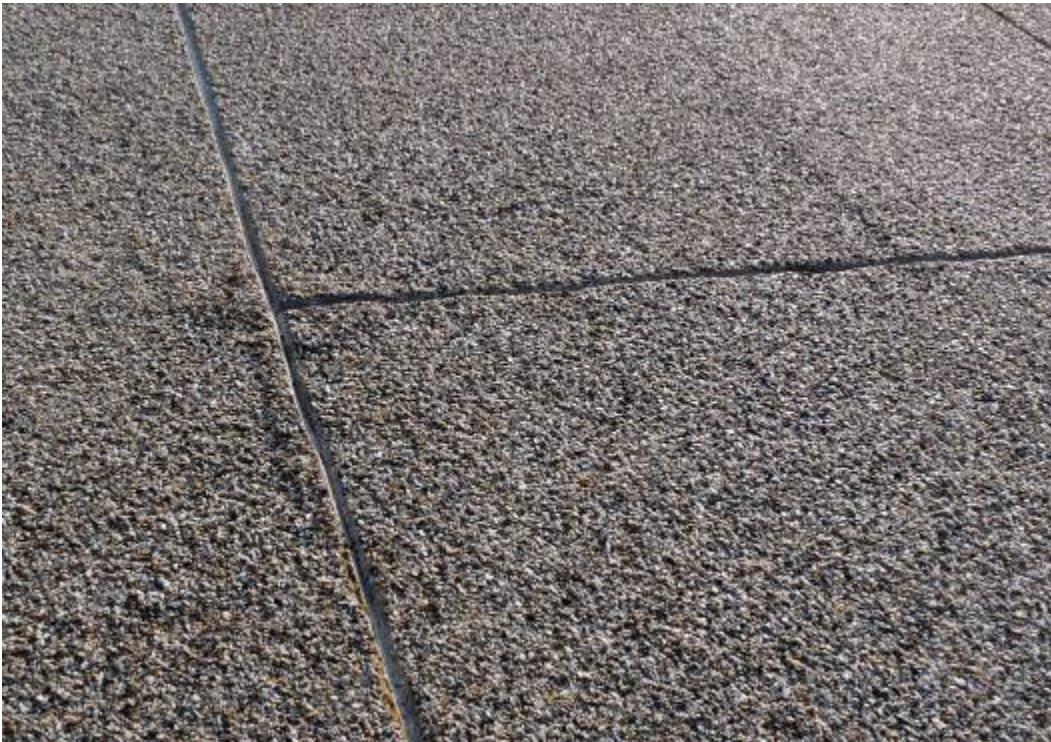
Figure 78. V-groove in wear surface.

After these initial repairs to the raised sheets and adjacent wear surfaces were finished, the reflective cracks were repaired. The cracks were cut open to provide a surface to adhere to the sealant. First, a straight cut was made to provide a guide for the second step (Figure 76), which was cutting a v-groove (Figure 77). The completed v-groove is visible in Figure 78. Once the v-groove was cut, the cracks were cleaned of dust and debris using compressed air. Next, a primer (Tremco Vulkem 171) was applied (Figure 79). This material was used at the suggestion of the sealant manufacturer because adhesion testing was not going to be practical for this particular repair, and the GFRP composite-sealant bond is not as common as bonds to other materials. Once the primer cured, the sealant (Tremco THC-901) was applied. The sealant was mixed in accordance with manufacturer's instructions, including the inclusion of a coloring agent to match the wear surface coloring. The sealant was applied with a bulk sealant gun (Figure 80). Before the sealant set, a scraper was used to remove excess material (Figure 81) and to ensure contact between the sealant bead and the top of the wear surface on each side of the joint (Figure 82). The completed repair is shown in Figure 83, and the procedure for the wear surface repair is documented in Appendix B, section B1.

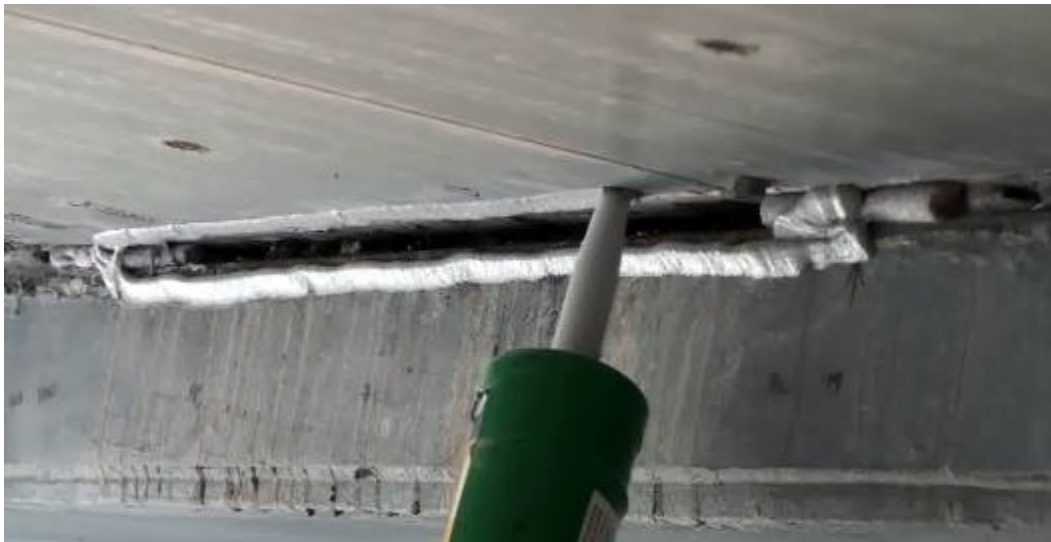
Figure 92. Caulking form joints.

Once the voids were identified, forms were attached to contain the repair material. First, mating surfaces on the bridge deck and steel grout haunch were mechanically cleaned using a scraper (Figure 91). Temporary forms to contain grout injected into the voids were fabricated from aluminum siding material bent to a right-angle profile. An injection hole was drilled in the “uphill” side of the form, where all of the voids were detected. In cases where the width of the void extended across the entire girder, aluminum containment forms were added to both sides of the girder, and a vent hole was drilled in the “downhill” side of the form in order to indicate the complete filling of the void and to avoid air entrapment. In cases where only one side of the girder allowed access to the void, vent holes were drilled on both sides of the injection hole to prevent air entrapment. In all cases, the mating surfaces for the aluminum containment forms were caulked using TremCo 626 sealant (Figure 92), and then the forms were

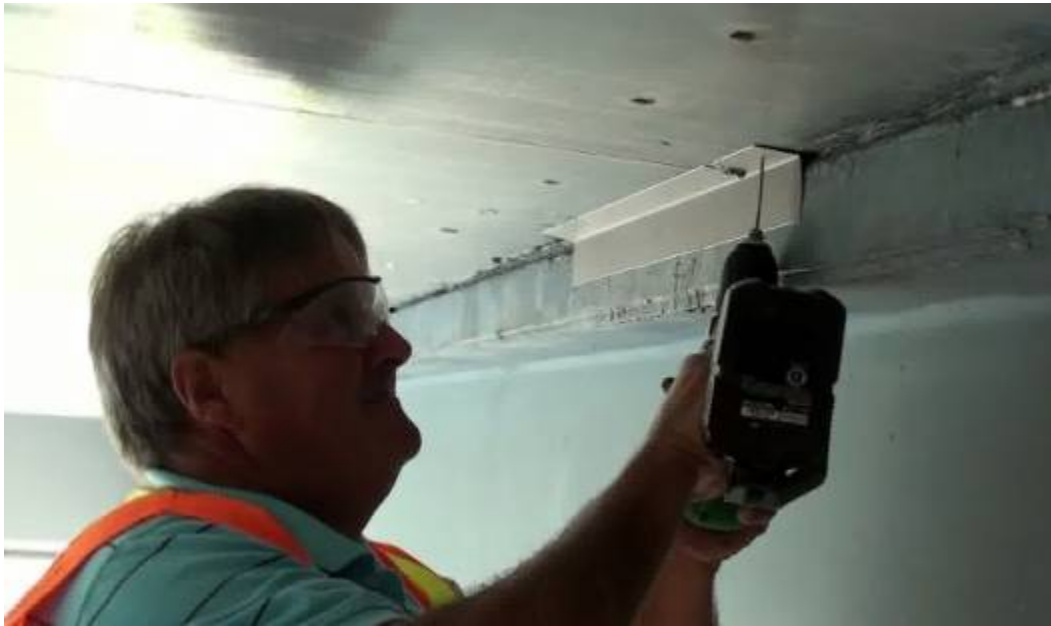
Figure 93. Drilling pilot holes for form attachment.

screwed into the bottom of the deck (Figure 93). Figure 94 shows the aluminum grout-containment form in place, drilled, and ready for grout injection.

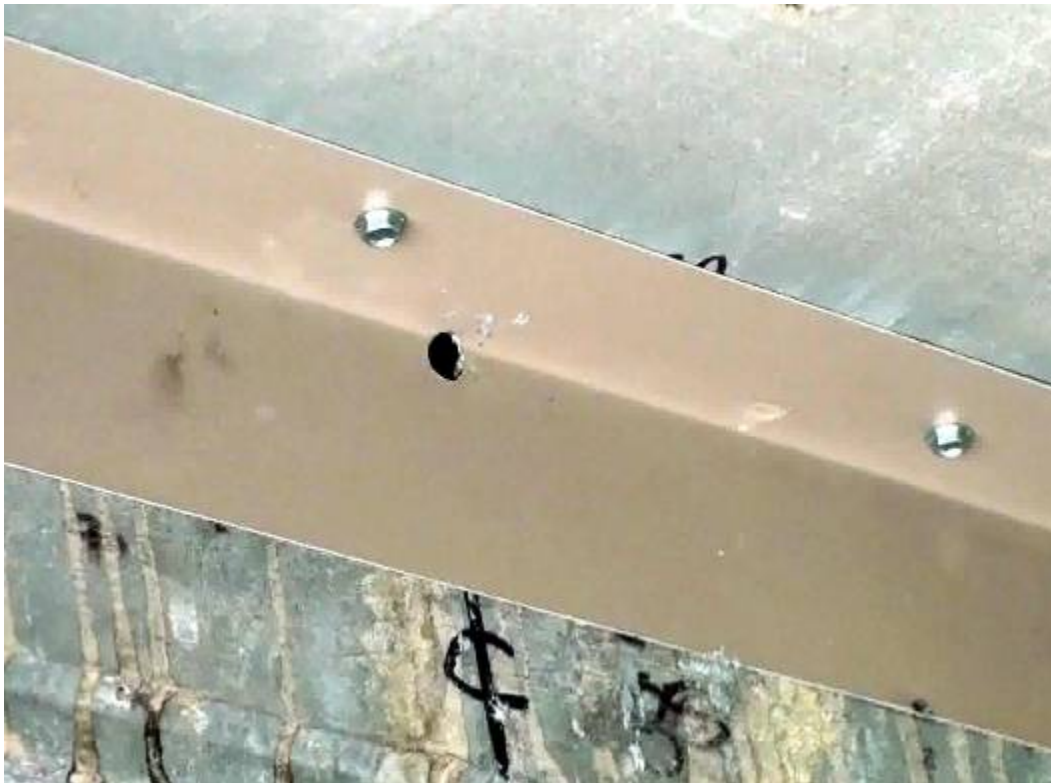
The repair material (Euco Cable Grout PTX from Euclid Chemical) was prepared and mixed. The manufacturer's mix instructions were scaled down from construction quantities to produce enough grout to fill the bulk loading sealant gun used for the procedure. Grout was injected into the void through the injection hole (Figure 95) until it began to leak through the vent holes (Figure 96). After injection, the holes were plugged and the grout was allowed to set for at least 24 hours.

Figure 95. Grout injection.

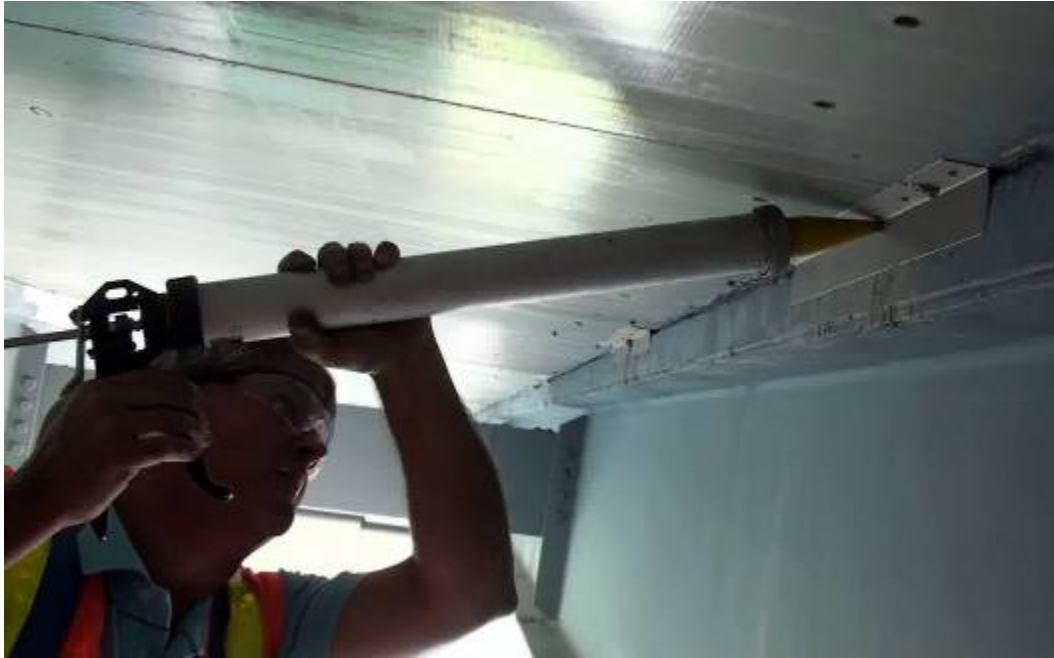
Figure 96. Back-side form with leaking grout.

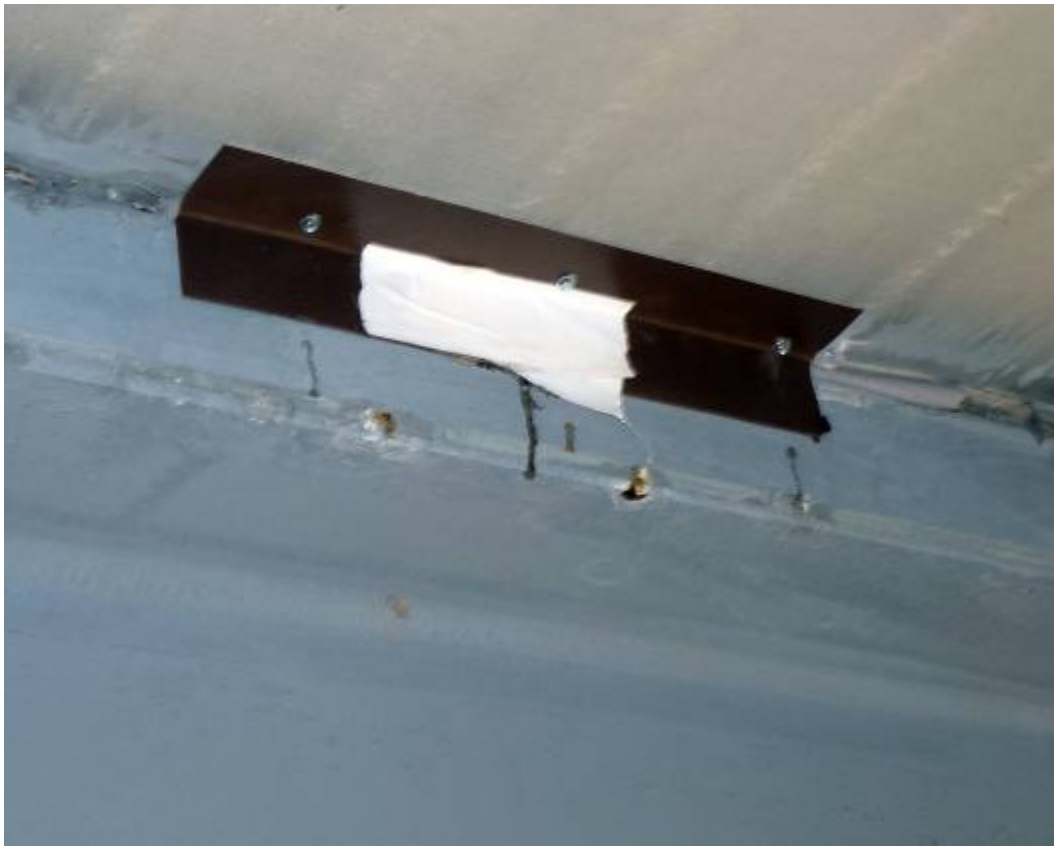
After the grout had set, the aluminum forms were removed (Figure 97) and the repair inspected. A repair immediately after form removal is shown in Figure 98. In three instances, the grout mixture was too thin and the aluminum forms failed to contain it. In these cases, the voids were re-formed, refilled, and allowed to cure for 24 hours. In all three cases, the second repair produced acceptable results. Once the repairs were inspected and accepted, excess caulk was removed (Figure 99), and any holes in the form plates were filled with caulk. The finished repair is shown in Figure 100.

Figure 97. Form removal.

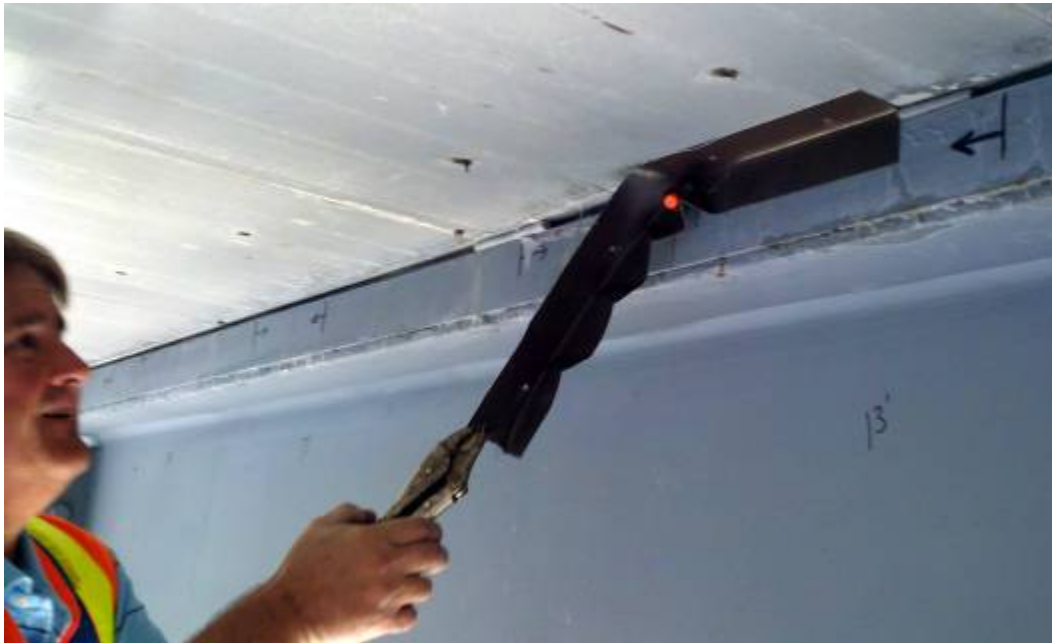
Figure 98. Raw repair after form removal.

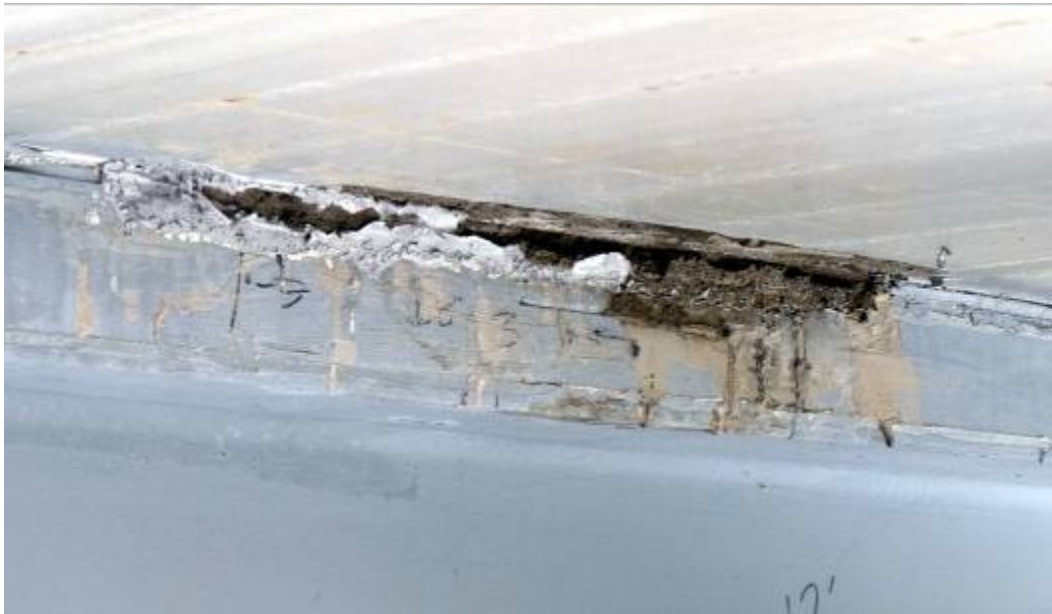
Figure 99. Repair finishing.

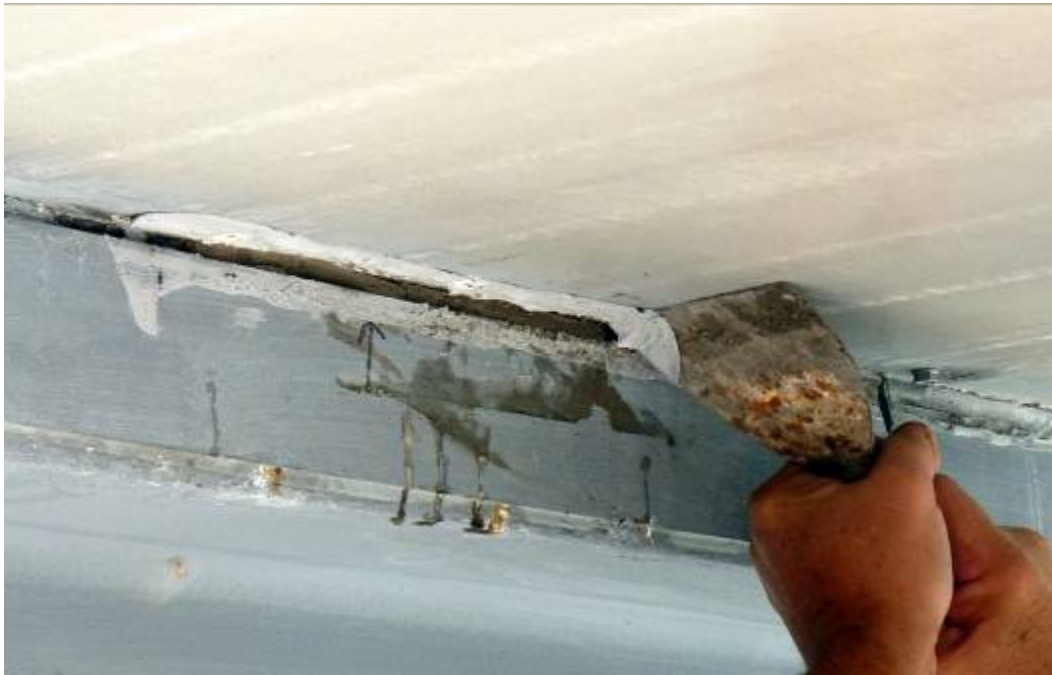
Figure 100. Finished repair.
